HOUSE LOCATION SURVEY
LOT 733

POPLAR TREE ESTATES
SECTION SEVEN
SULLY DISTRICT
FAIRFAX COUNTY, VIRGINIA

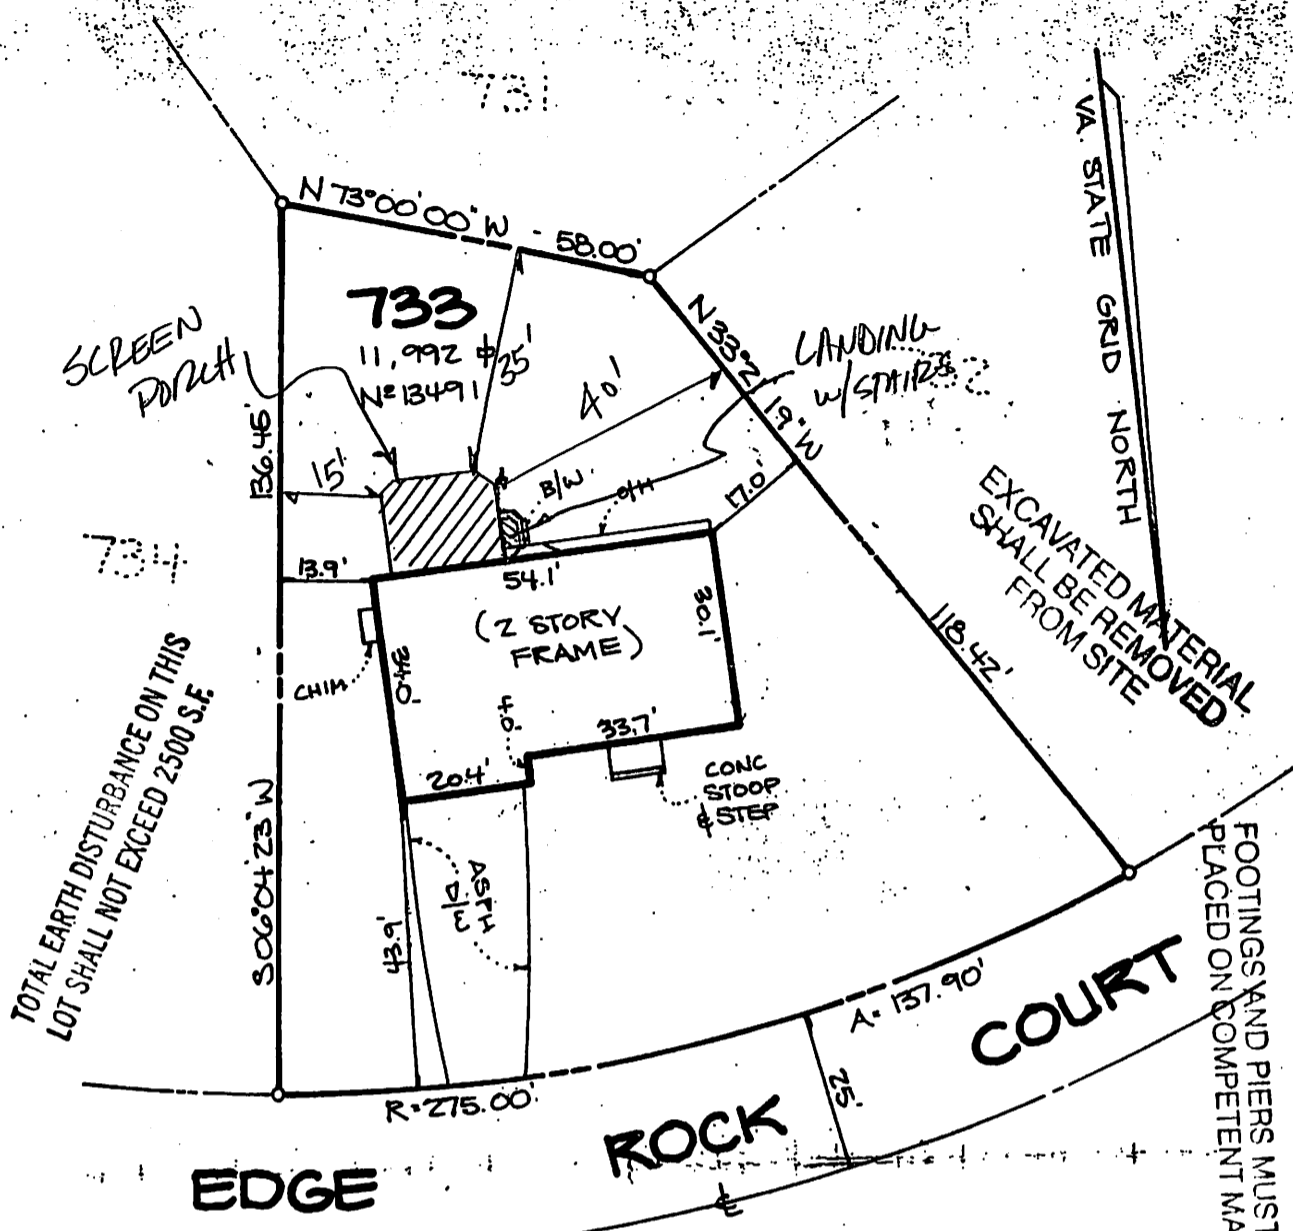
The Area Depicted Hereon Lies in Flood Zone C (Minimum Flood Hazard) as Shown on the Flood Insurance Rate Map Page 2 of the County of Fairfax.

The Fairfax County Soil Survey indicates that plastic clays may occur on this property. Foundation footings for any structures must extend below any zone of plastic clay to firm undrained weathered or hard bedrock. Foundation footings should be inspected by the building inspector to insure this requirement.

EX. EASEMENTS ARE RECORDED IN DB 7482 2.462 UNLESS OTHERWISE NOTED
WALL CHECK: 9-13-93
FINAL: 11-1-93

SURVEYOR'S CERTIFICATE
I HEREBY CERTIFY THAT THE LOCATIONS OF ALL EXISTING IMPROVEMENTS ON THIS PROPERTY HAVE BEEN CAREFULLY ESTABLISHED BY A TRANSIT-TAPE SURVEY AND UNLESS OTHERWISE SHOWN, THERE ARE NO ENCROACHMENTS. NO TITLE REPORT FURNISHED.
